Situation Photo Log

Wednesday, May 16, 2012

Kalamazoo River / Enbridge Spill

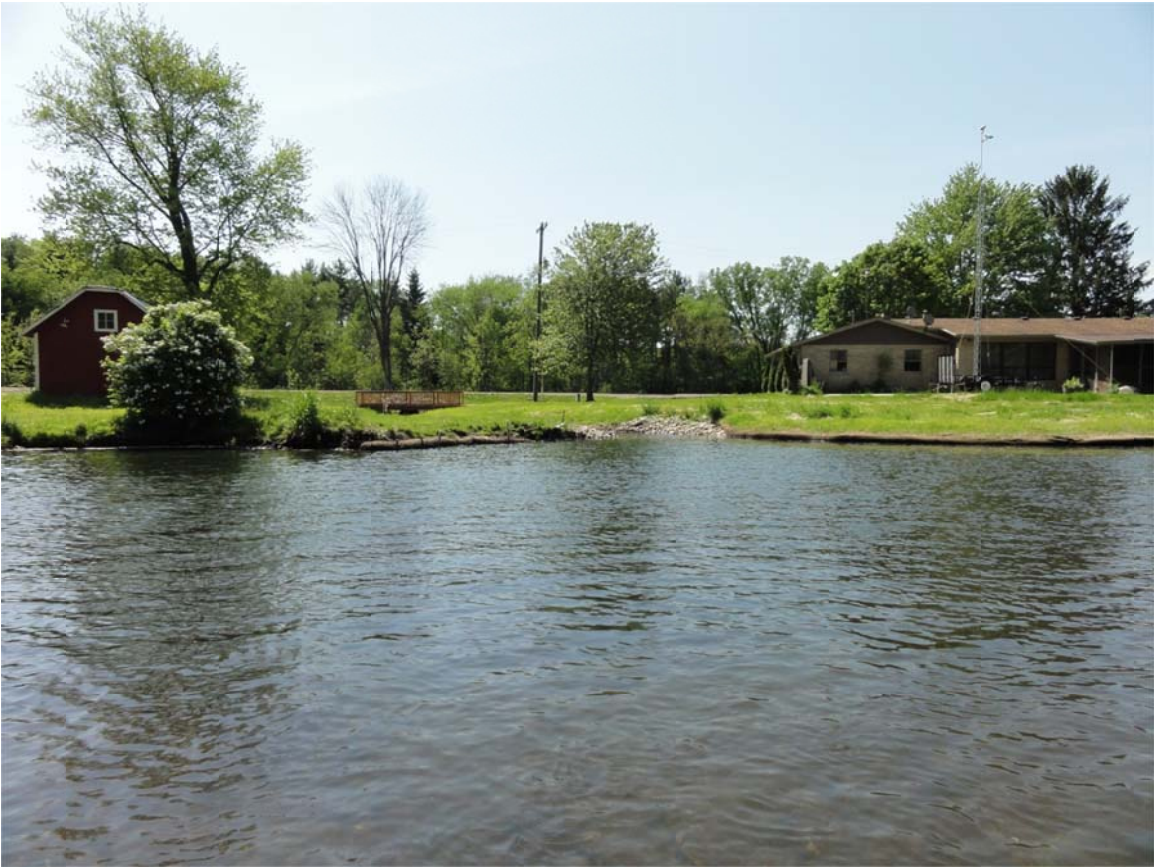
1. View of Confluence from river. No sheen observed.

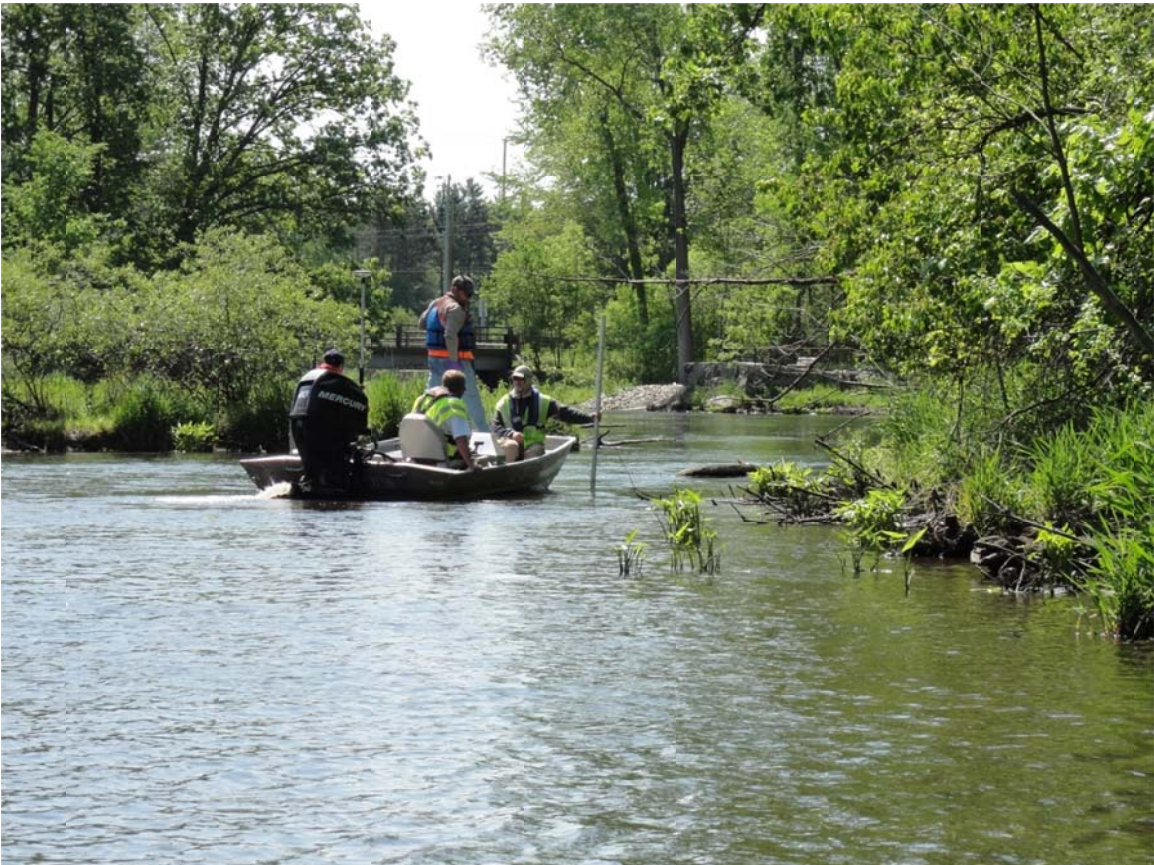
2. Poling crew near MP 2.25 just downstream from Saylor's Landing.

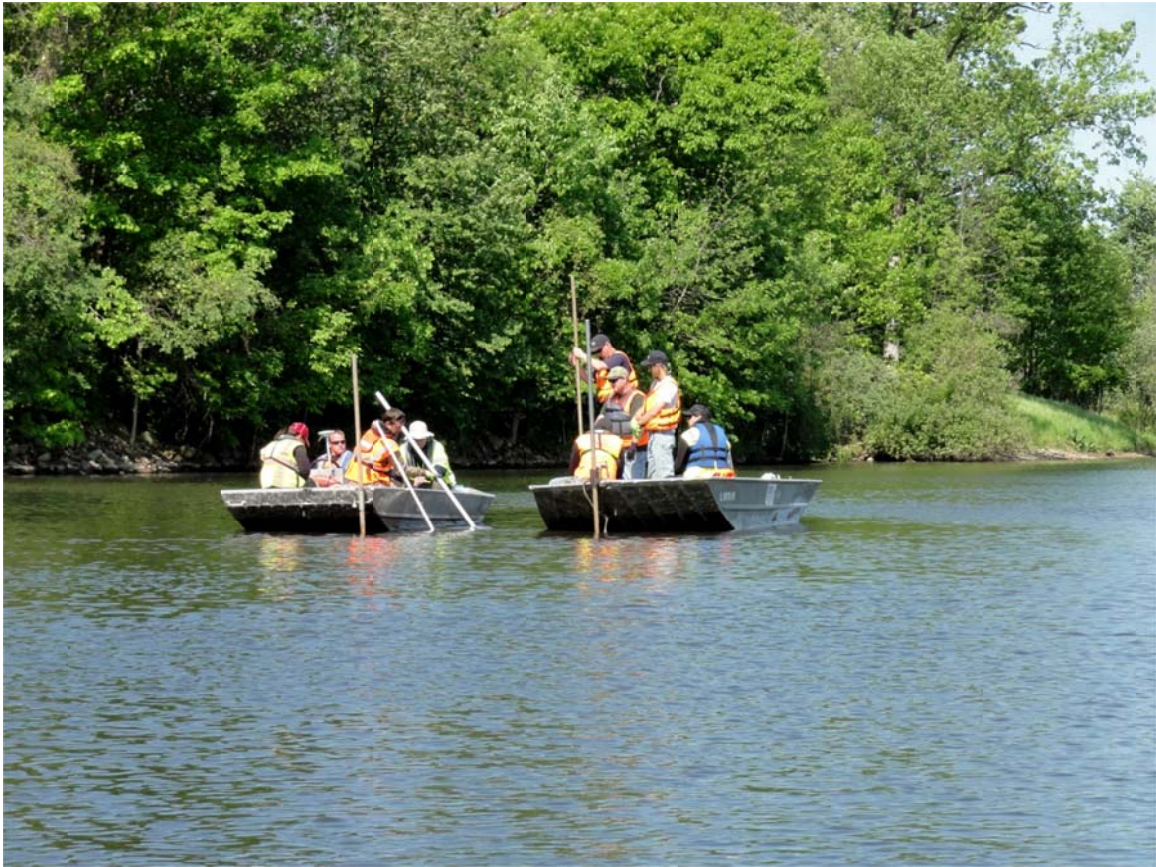
3. Poling crews just downstream from C0.4 boat launch.

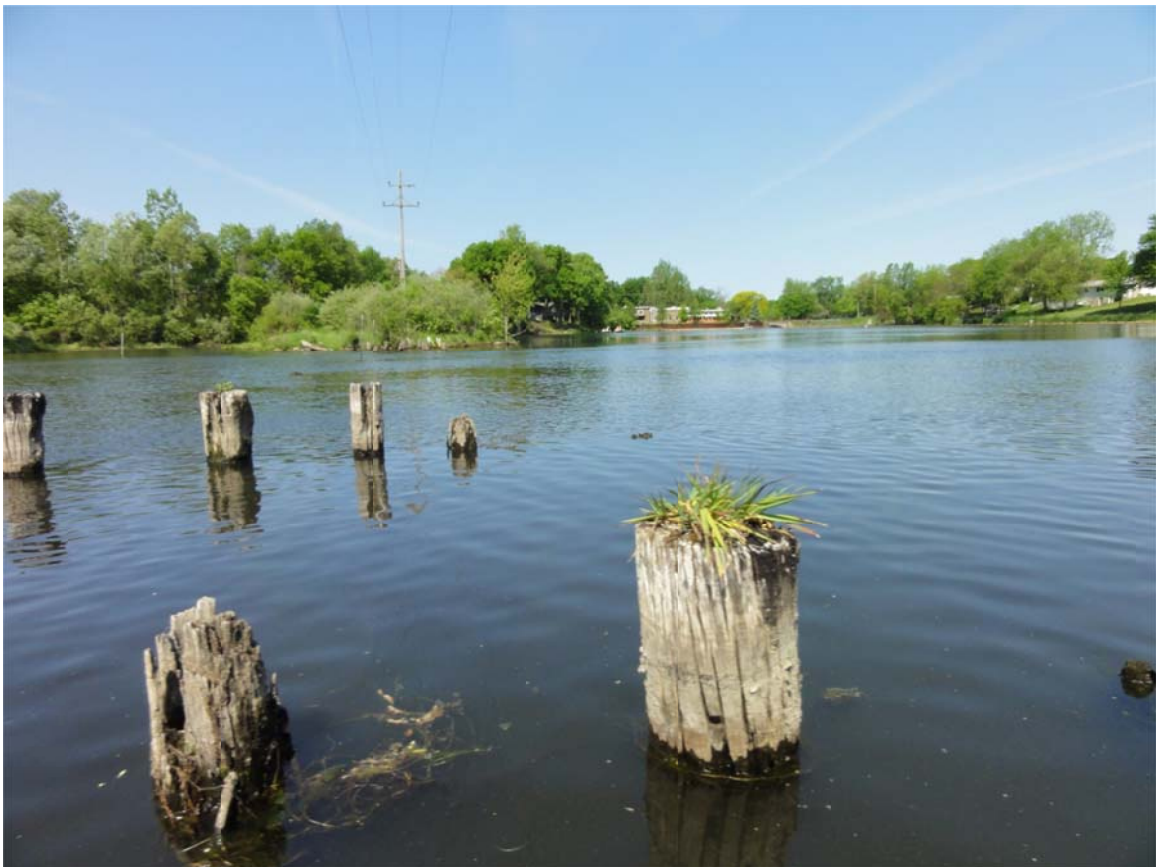
4. View from MP 5.75 RDB, looking downstream at Ceresco Dam. No sheen observed here today.

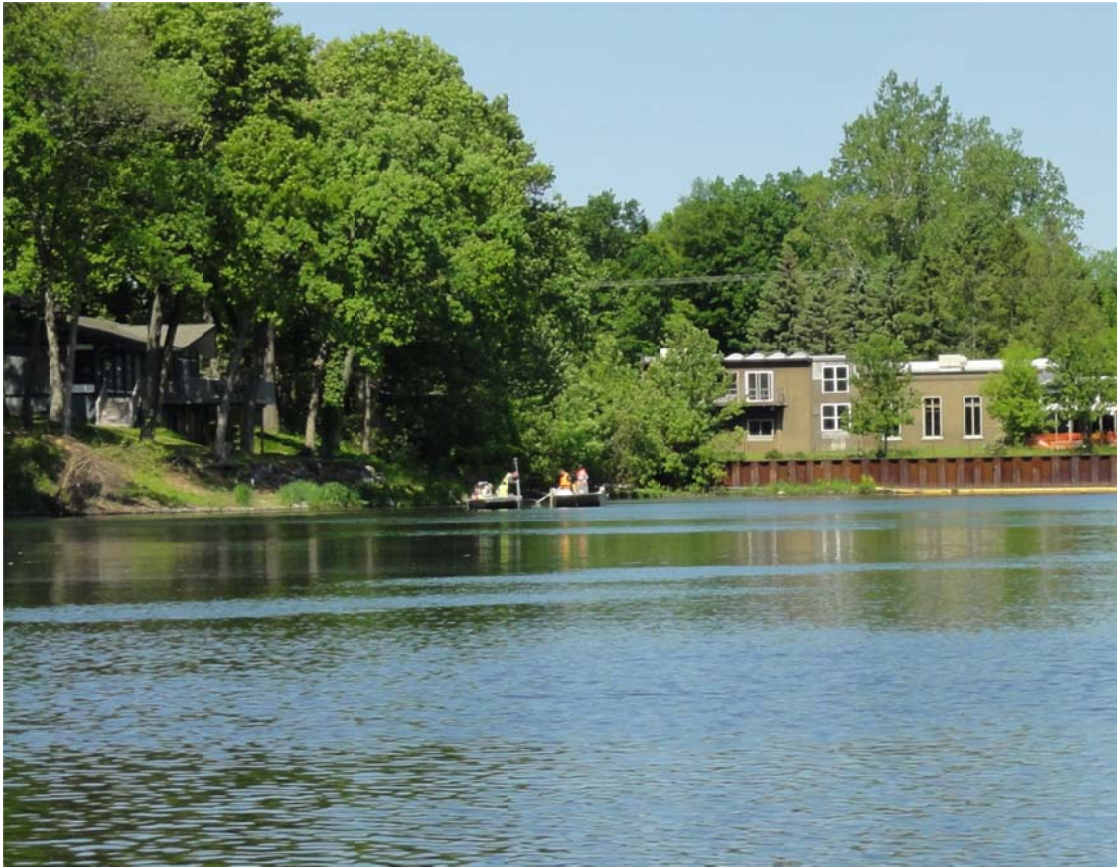
5. Poling crew near LDB upstream from Ceresco Dam.

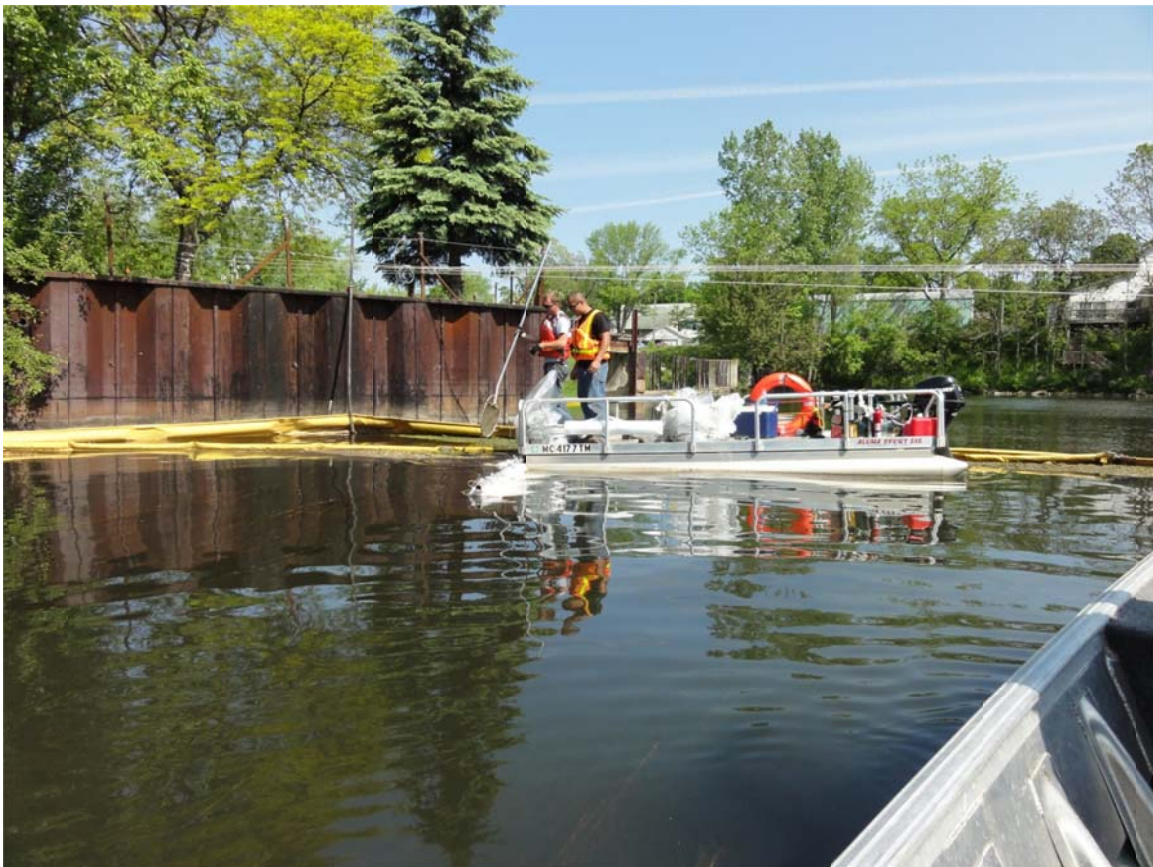
6. Crews removing vegetation and debris from control point at Ceresco Dam.

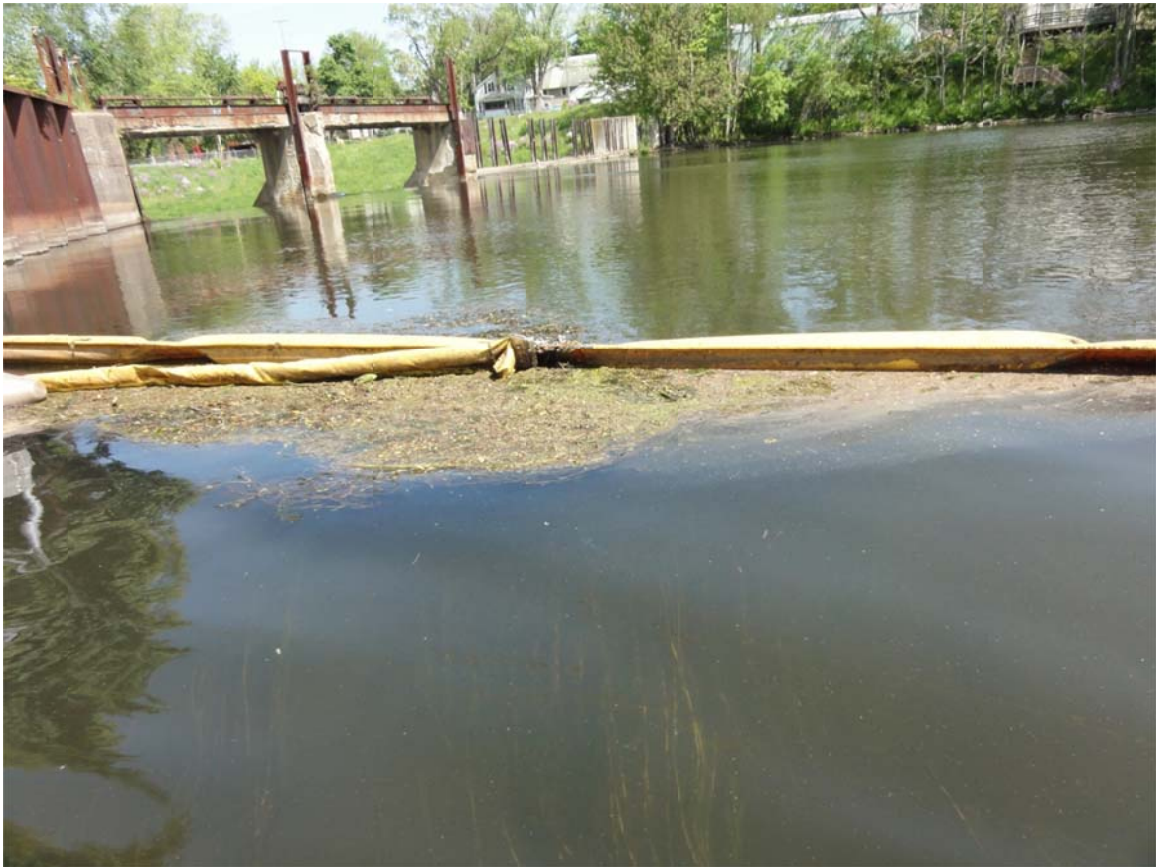
7. Vegetation, debris, and sheen within control point above Ceresco Dam.

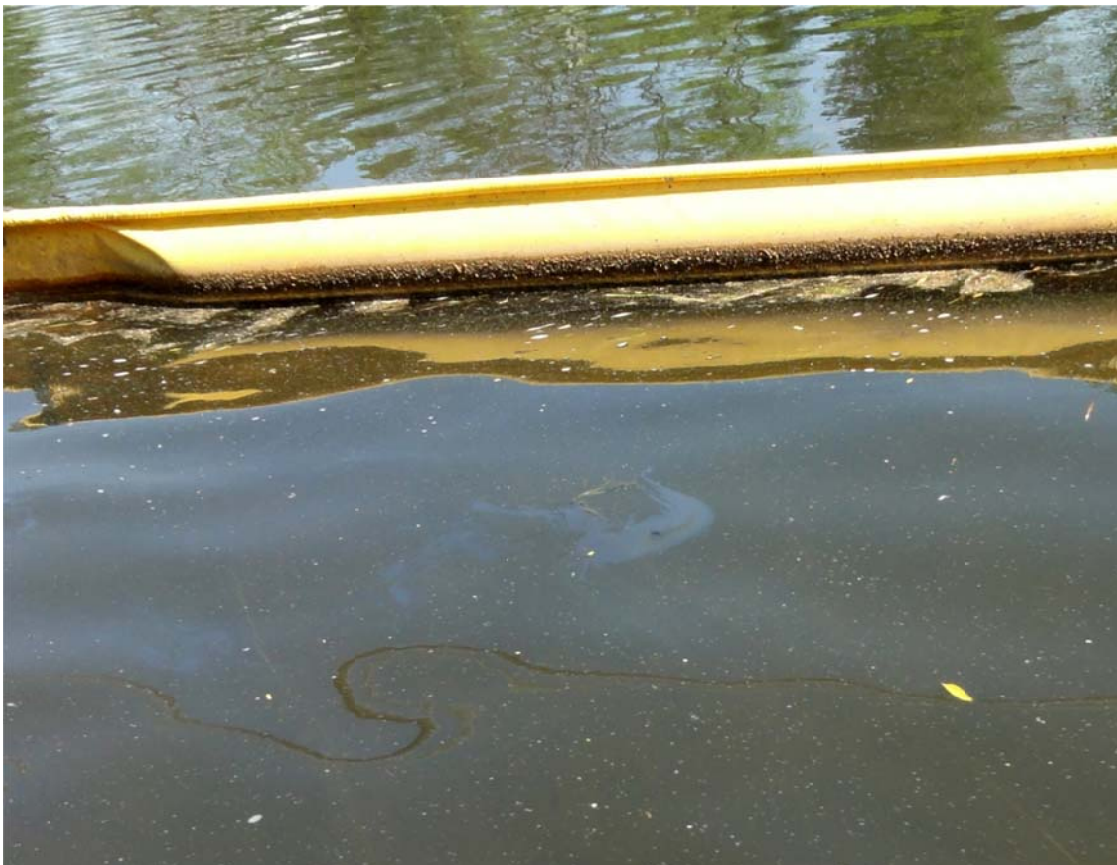
8. Oil globules and sheen within containment at Ceresco Dam control point.

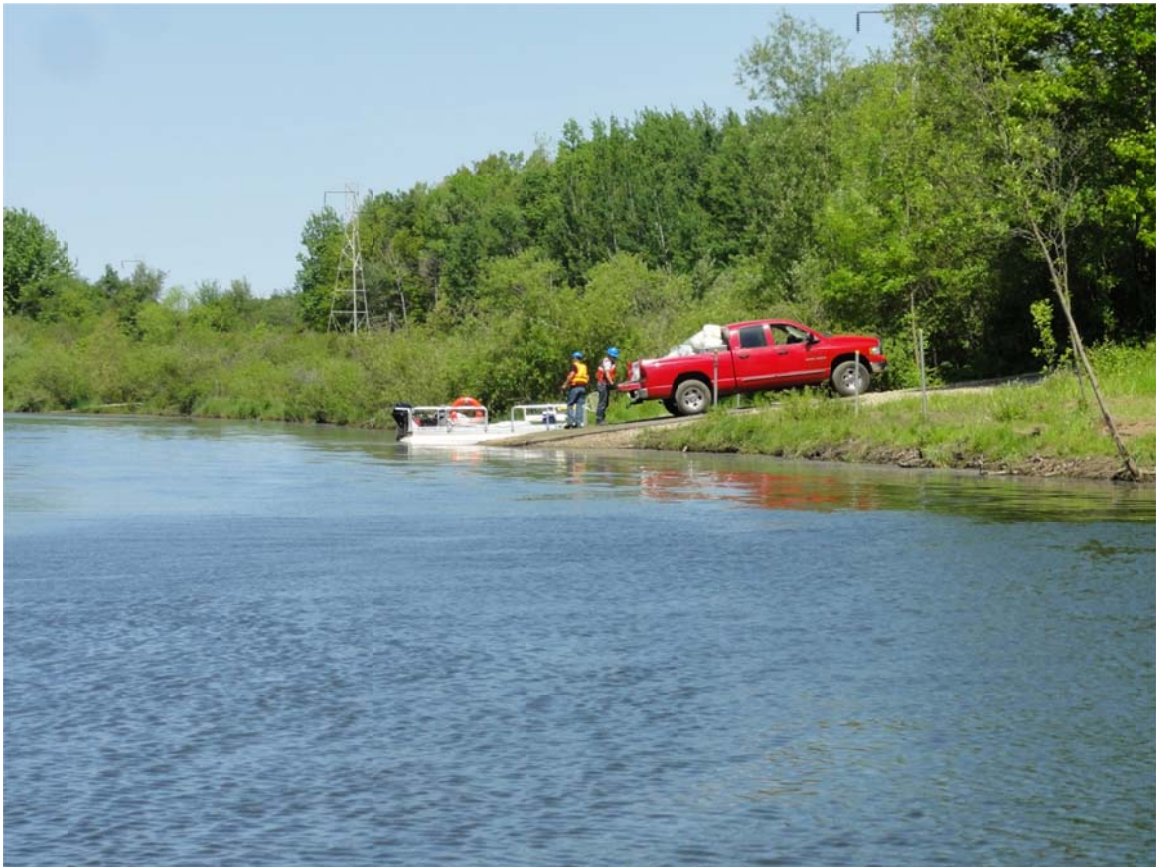
9. Crews at C0.4 boat launch, loading debris removed from Ceresco Dam control point.

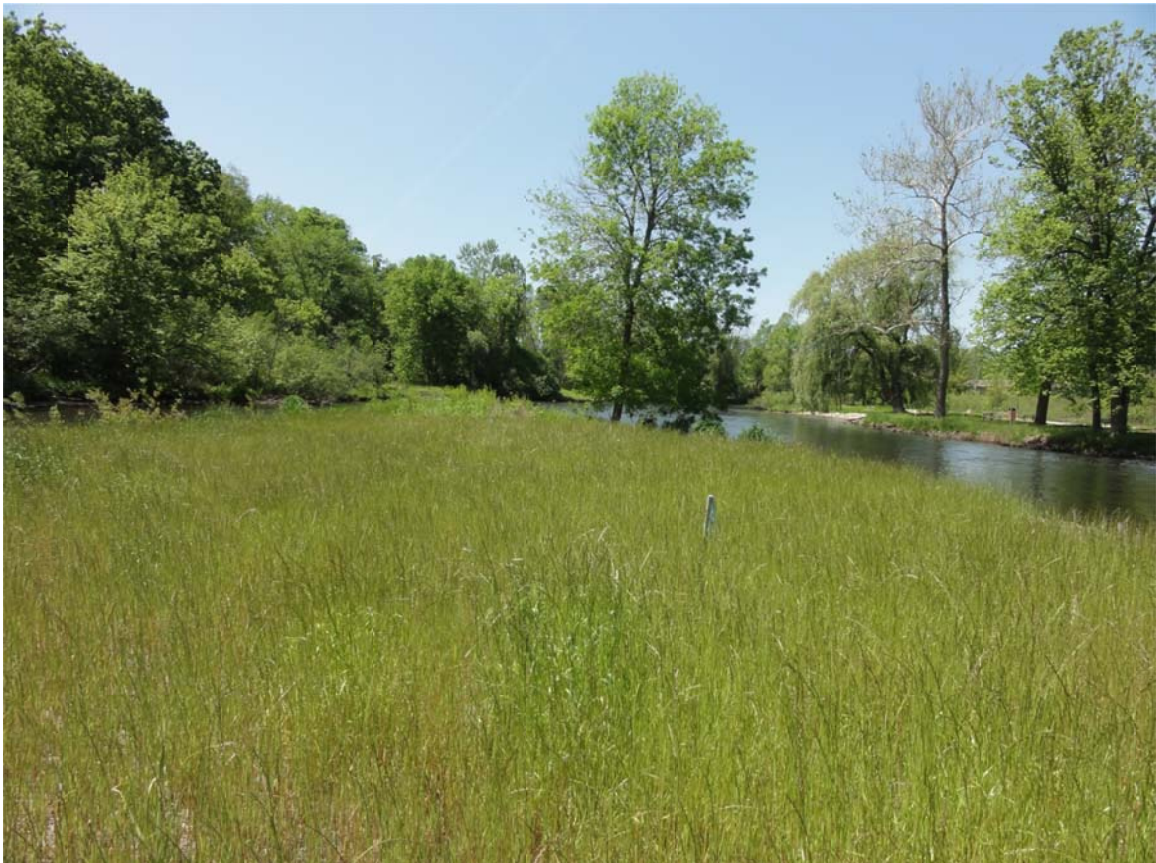
10. Former excavation site on Island at MP9.5. No sheen observed.

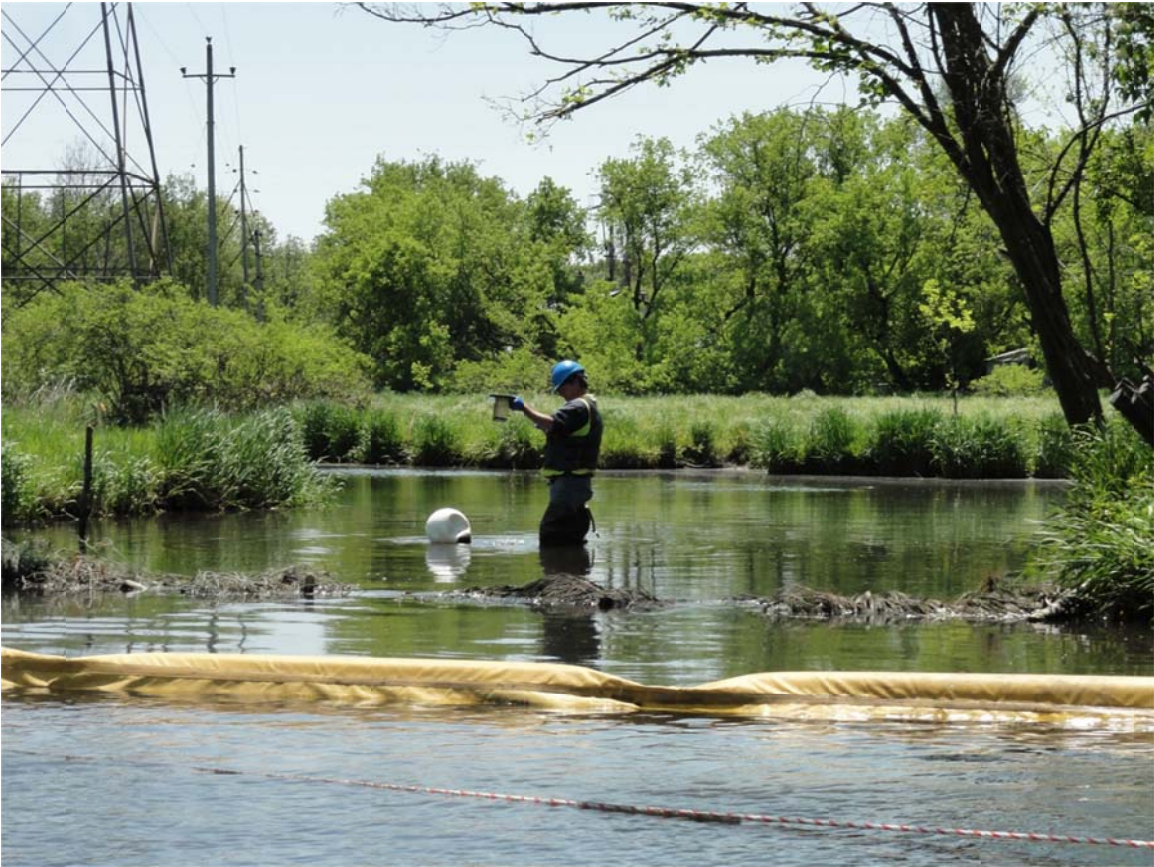
11. Crews inspecting sediment sample at 10.75 LDB sediment trap location.

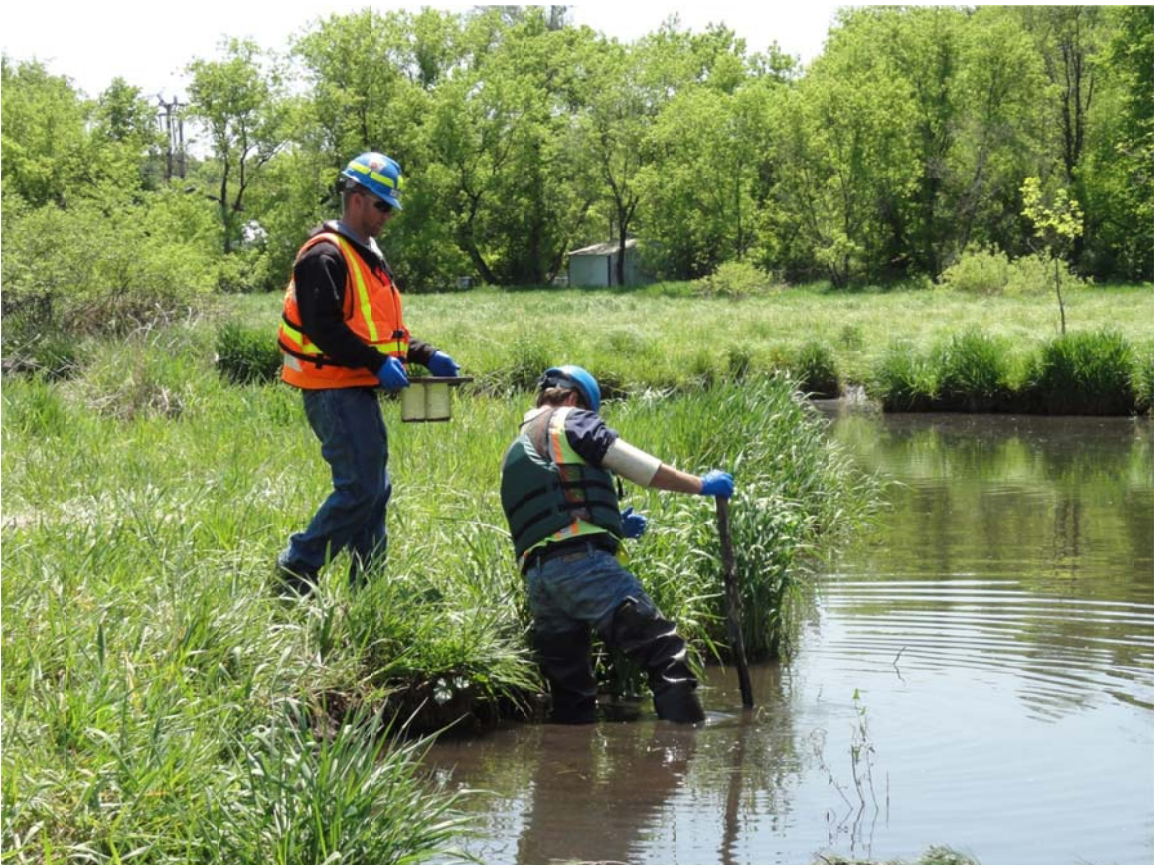
12. Crews inspecting sediment sample at 10.75 LDB sediment trap location.

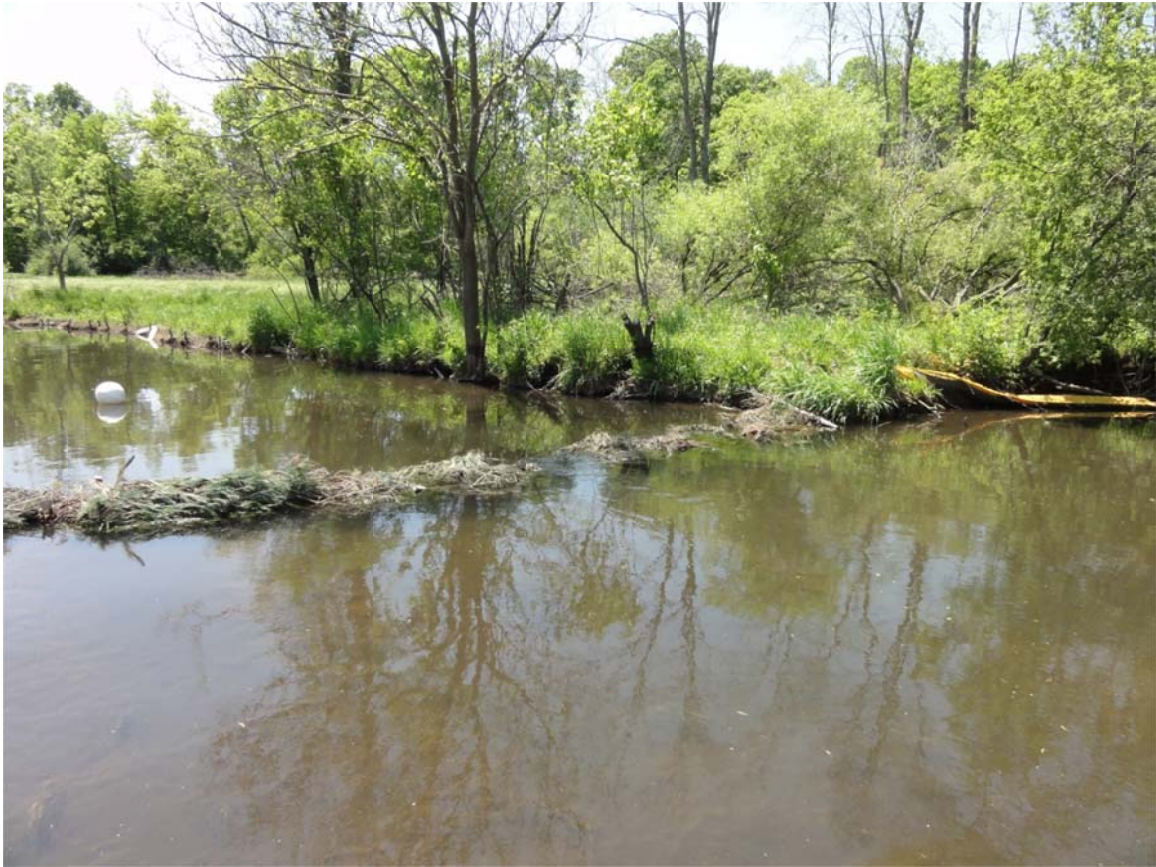
13. MP 10.75 LDB sediment trap. No sheen observed along shoreline behind control point.

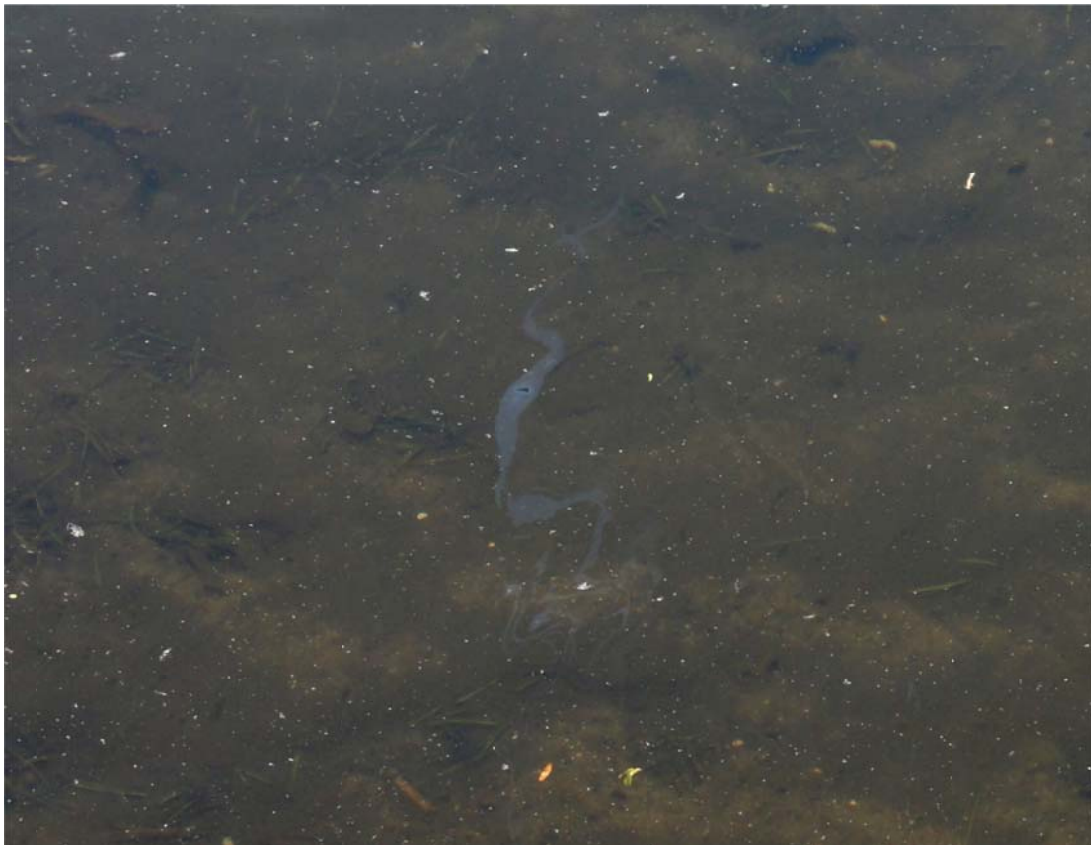
14. Tar globule and sheen within containment at MP 10.75 sediment trap.

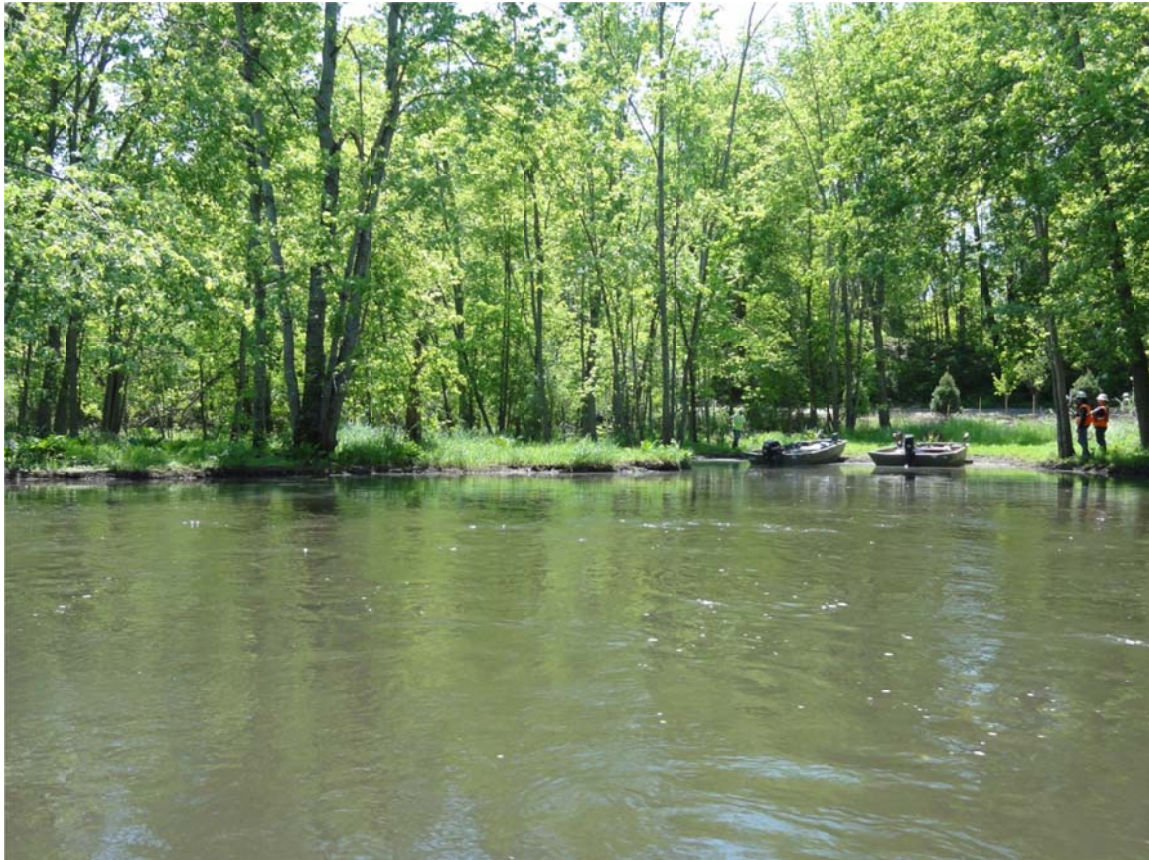
15. RI crews near MP 11.00 LDB.

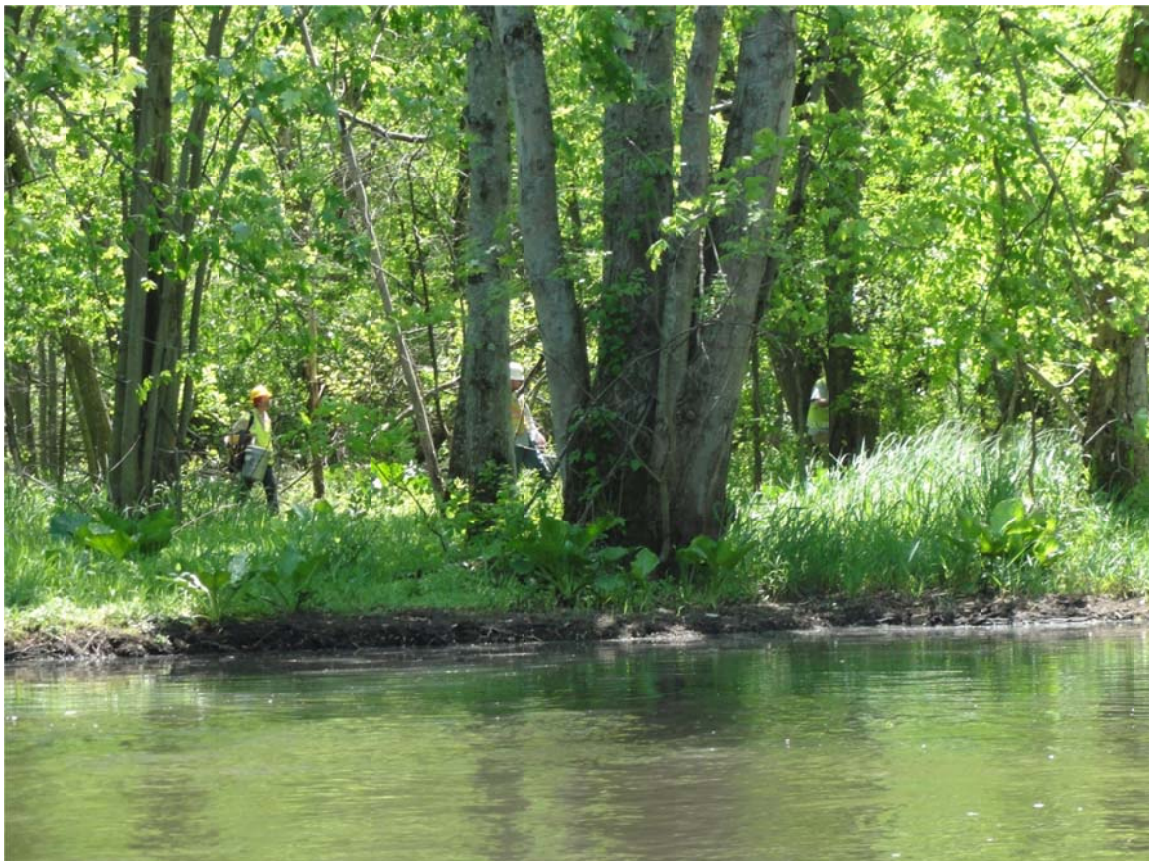
16. RI crews near MP 11.0 LDB.

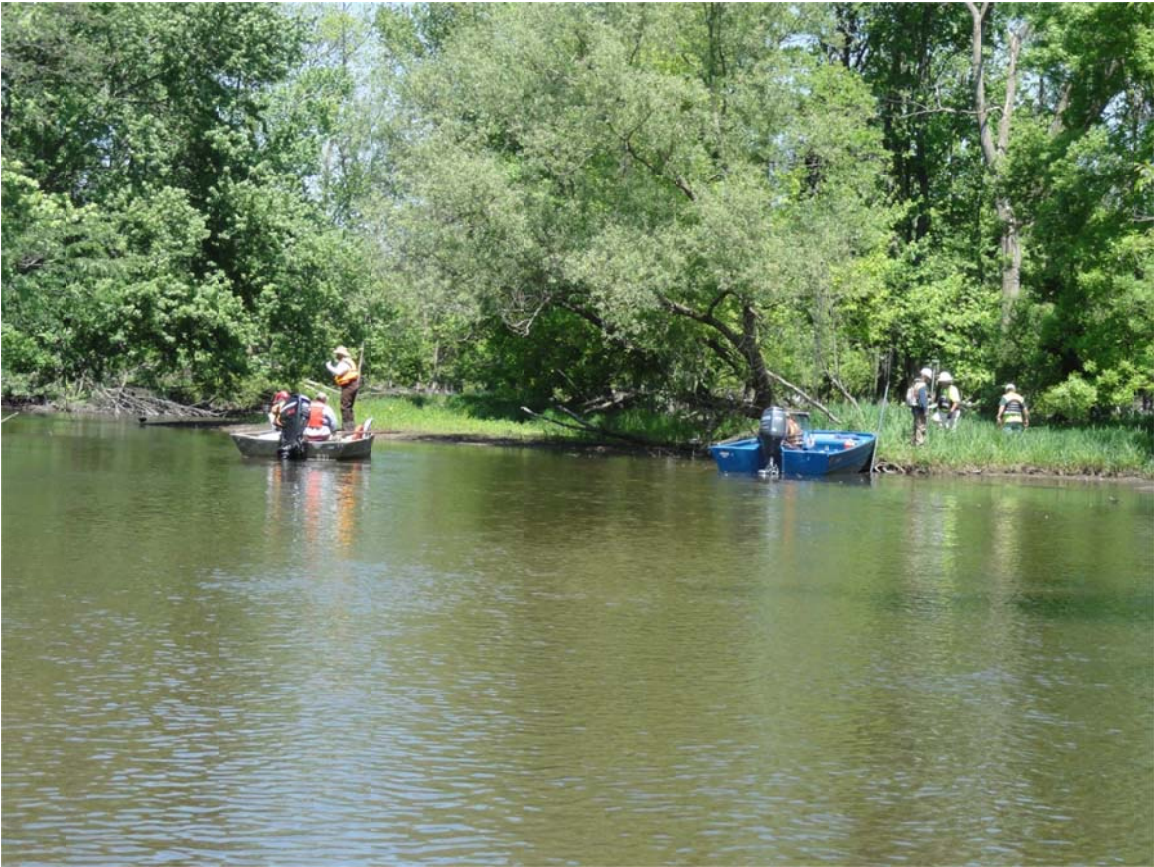
17. Poling crews in back channel near MP12.50.
